Subject: Gasoline-related testing of water supply well at:
«ADDRESS», «TOWN», NH

MtBE Remediation Bureau **Drinking Water Quality Program** **New Ipswich, NH** **Updated: 6/7/2017**

MtBE in Drinking Water

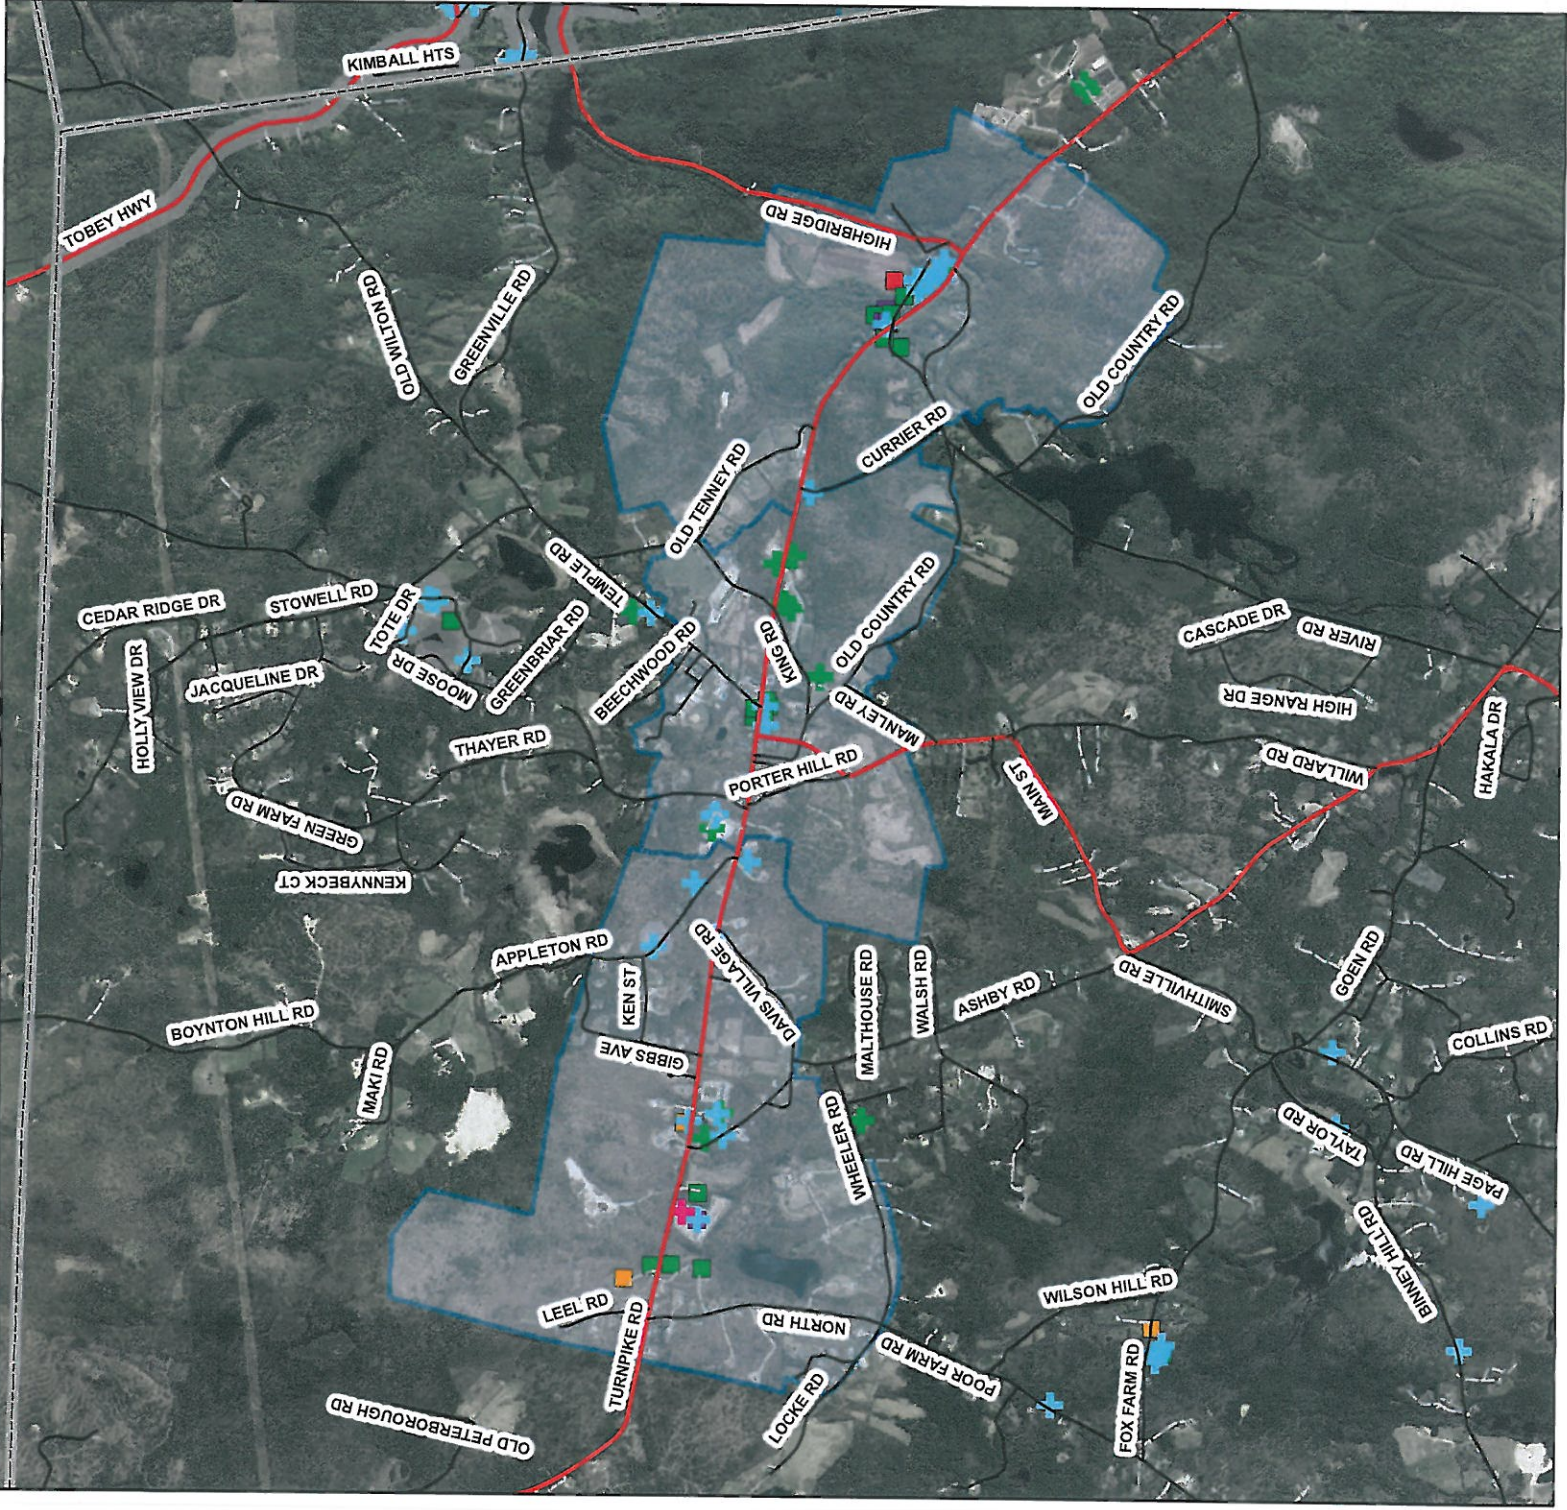
The concentrations displayed in the map represent the most recent MtBE concentration in the NHDES database. Other samples may have been collected that are not in the database.

- + Auto Salvage
 - + Remedial Site
 - + UST
 - New Sampling District
 - Water Distribution (limited receptors)
- MtBE (ug/L)**
- Below Detection
 - < 0.5
 - 0.5 - 4.99
 - 5 - 12.99
 - ≥ 13
 - VOC Results Pending
